Advisory Region Bridger Range Bridger Range, 2013-11-04

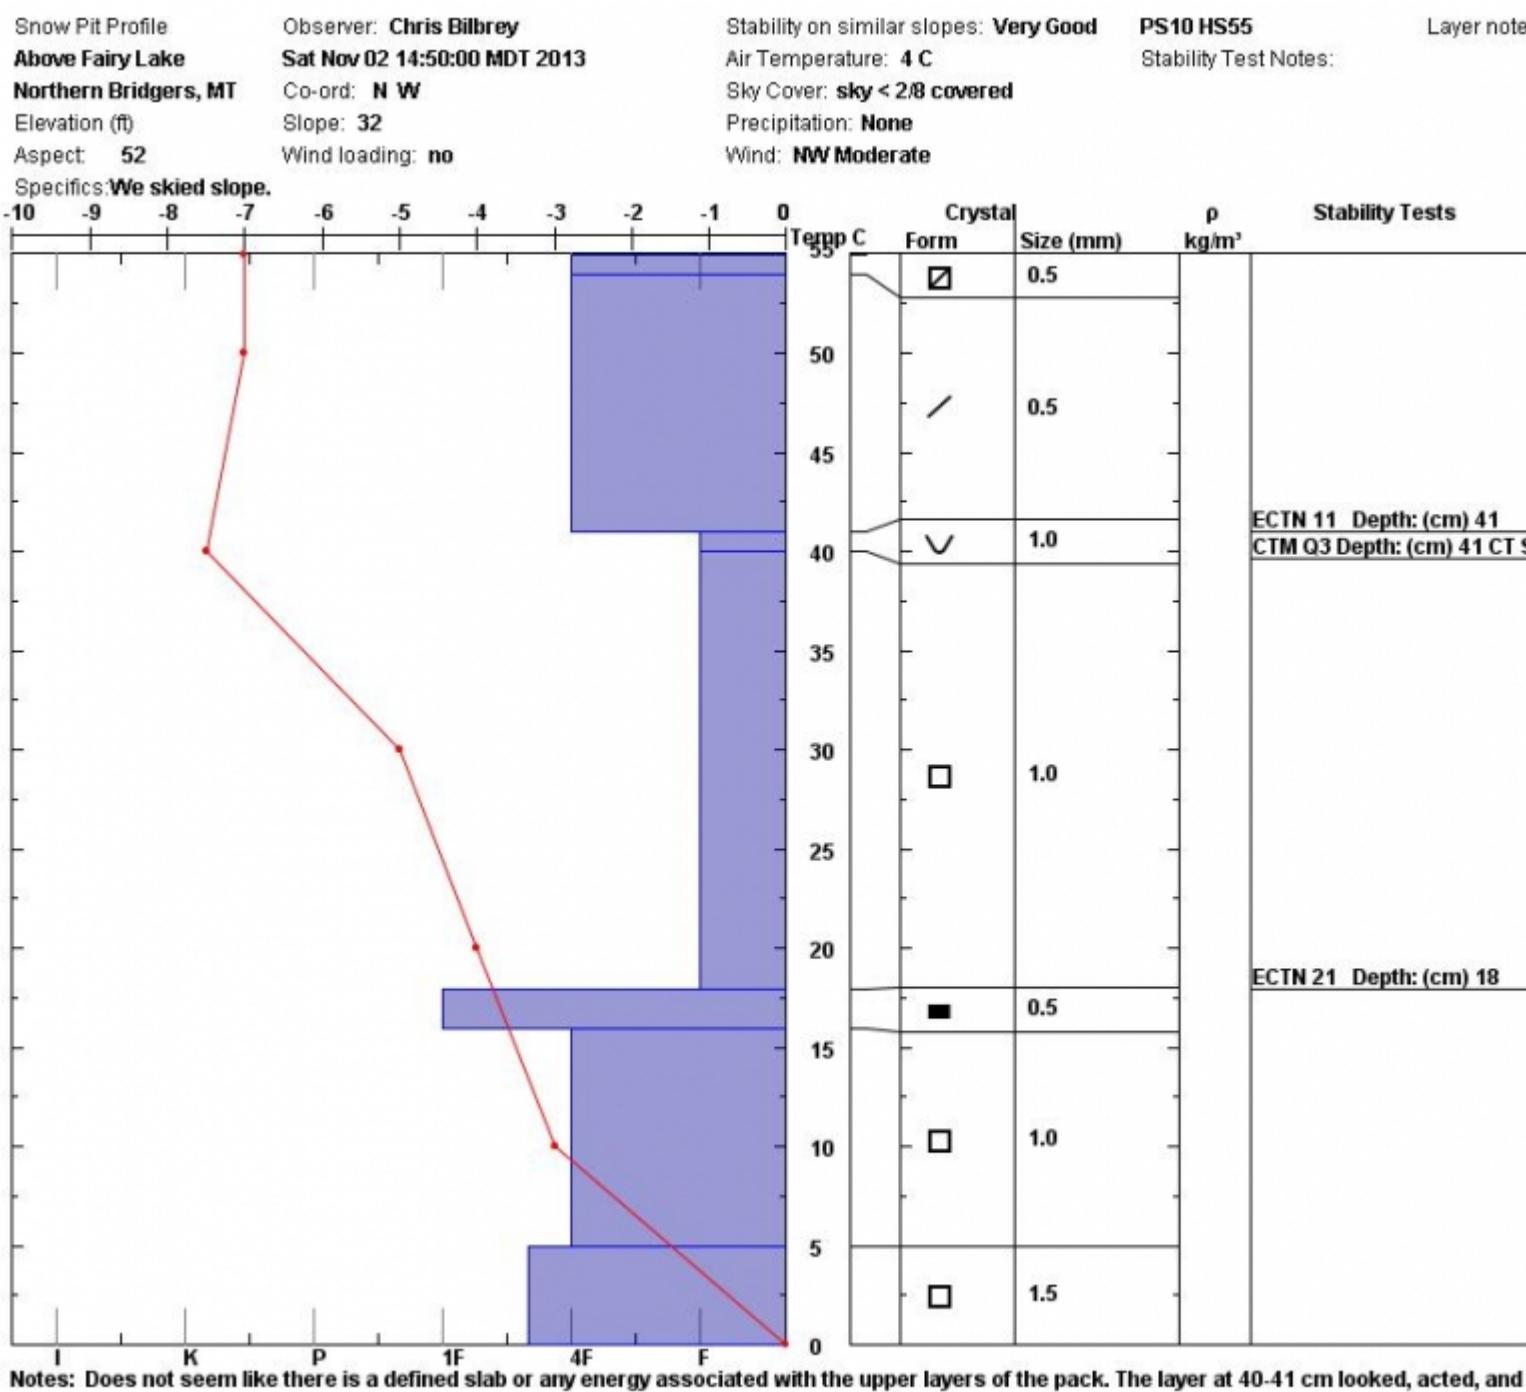
Notes: Does not seem like there is a defined slab or any energy associated with the upper layers of the pack. The layer at 40-41 cm looked, acted, and surface hoar and looked decomposed and to be rounding. Clean fracture surface at 41 cm with a CT but no movement into the pit. ECT showe propensity to fracture within any specific layers. No collapsing or any other signs of instability noted.
