Chris Bilbrey
Thu Feb 2 12:15 2017
 Co-ord: **45.57759N, -110.95518W**
 Slope Angle: **30°**
 Wind Loading: **no**

No Region, 2017-02-02

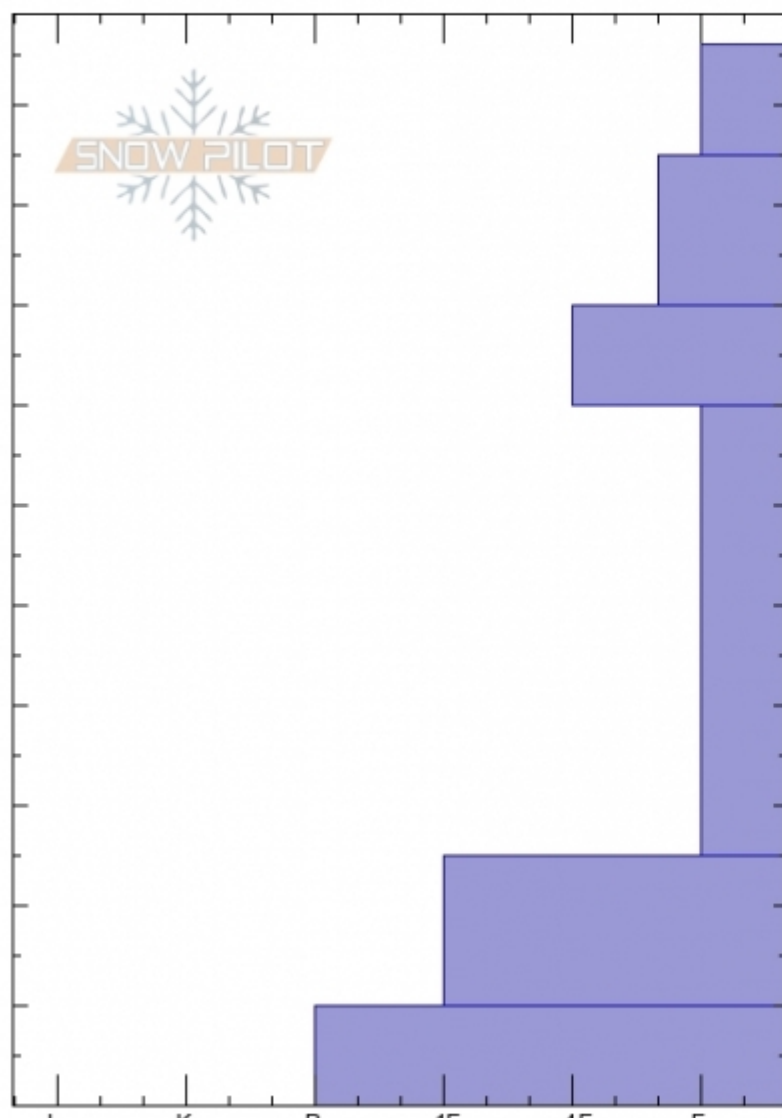
Specifics: Collapsing, localized; Cracking; Ski tracks on slope

Notes: Approx 20 hits before depth hoar began to sluff away below shovel. After digging pit, we traversed skier's right approx 50 feet a collapse and cracking of the new snow slab sitting on top of a buried surface hoar layer. No surface hoar noted in the pit we dug location. We observed ECTP 11 and ECTP 6 on the buried surface hoar layer at the location of the collapse and cracking. We descended ridge to the lower angle terrain skier's right of the burn area.
