Snow Pit Profile Cleo's Needle Hyalite - N. Gallatin, Elevation (ff) 8100 Aspect: 100 Specifics: Observer: Ben VandenBos Mon Nov 21 14:00:00 MST 2011 Co-ord: 45.43200 N 110.975132 W Slope: 30 Wind loading: previous Stability on similar slopes: Air Temperature: C Sky Cover: sky 3/8 to 4/8 covered Precipitation: None Wind: Light Breeze HS75 Stability Test Notes: Layer note 21-23: Pro

Advisory Region Northern Gallatin Northern Gallatin, 2011-11-22

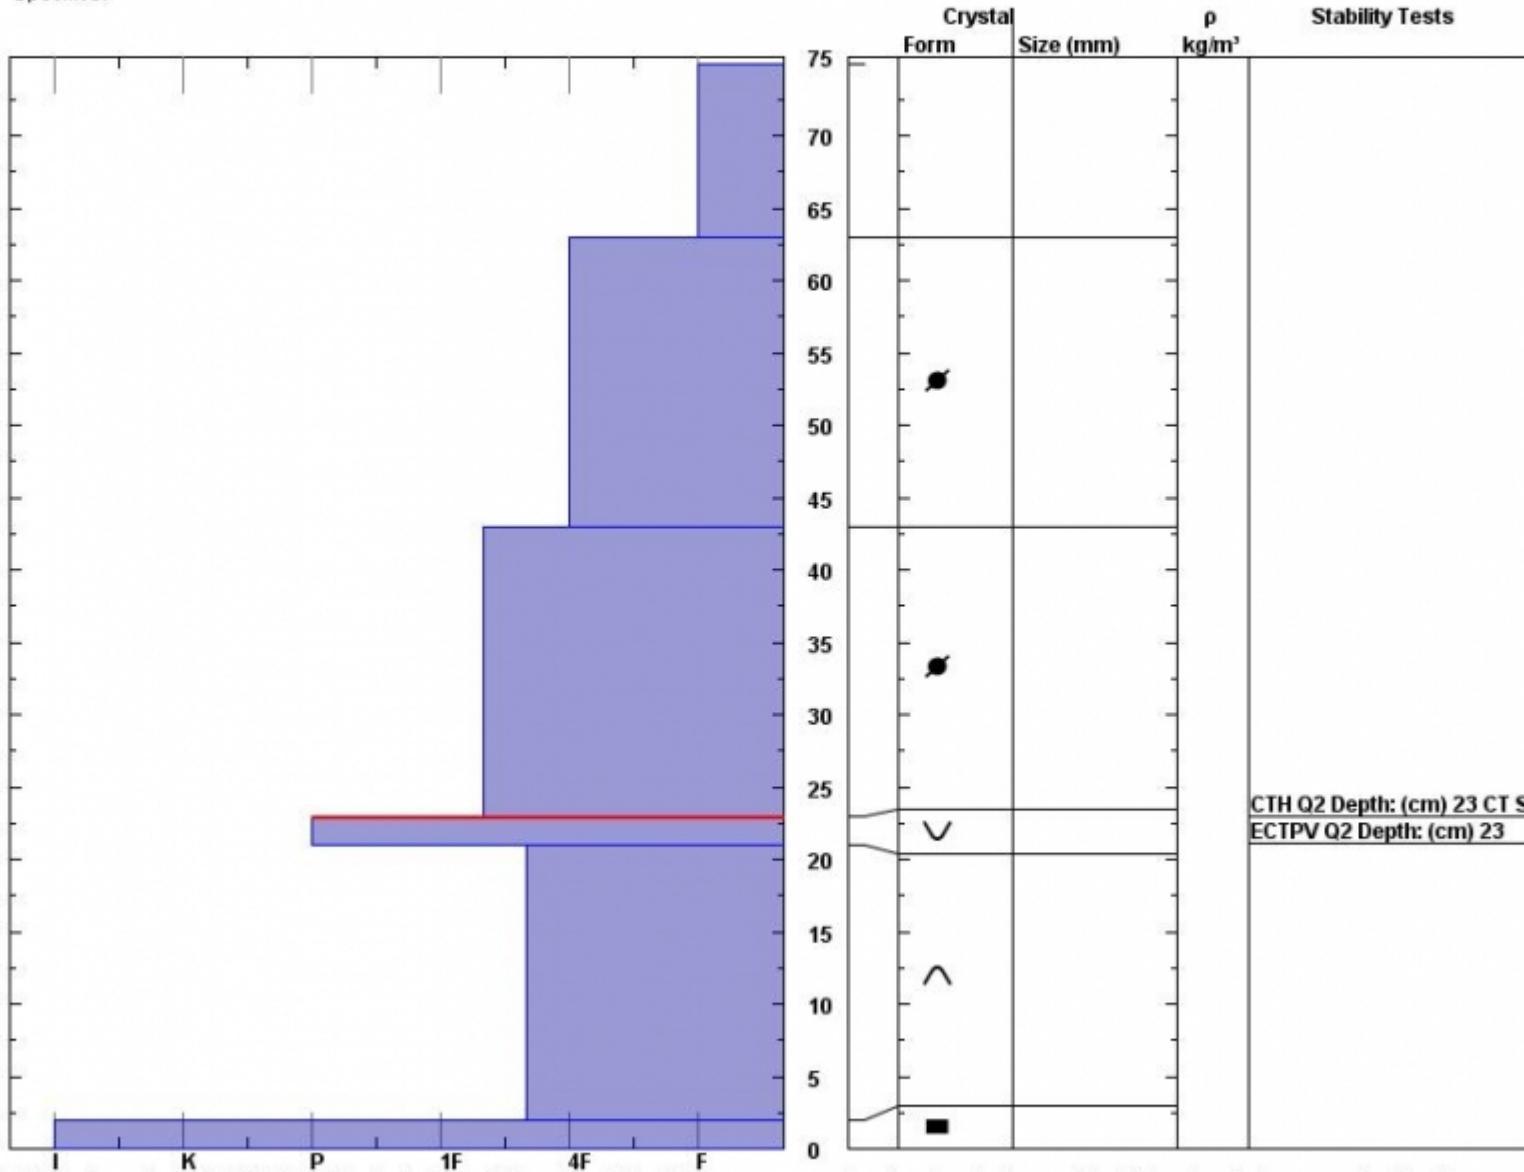
I K P 1F 4F F U Notes: Dug pit about 100' below the first pitch of Cleopatra's Needle. I was unsure how to classify the quality of the shearing because the blocks came some energy but the shear surface was very uneven. Surface undulations were on the order of 2-5 cm. The extended column failed on isolation is a bit misleading because I was poorly equiped for isolating extended columns and the outward force of my hand moving the saw up and dow considerable. They entire upper portion of the snowpack (above 23cm) was a progresively denser (moving downward) soft slab with very good
