Snow Pit Profile
 Observer: Eric Knoff

Mt Blackmore
 Tue Nov 22 12:32:00 MST 2011

Northern Gallatin, MT
 Co-ord: N W

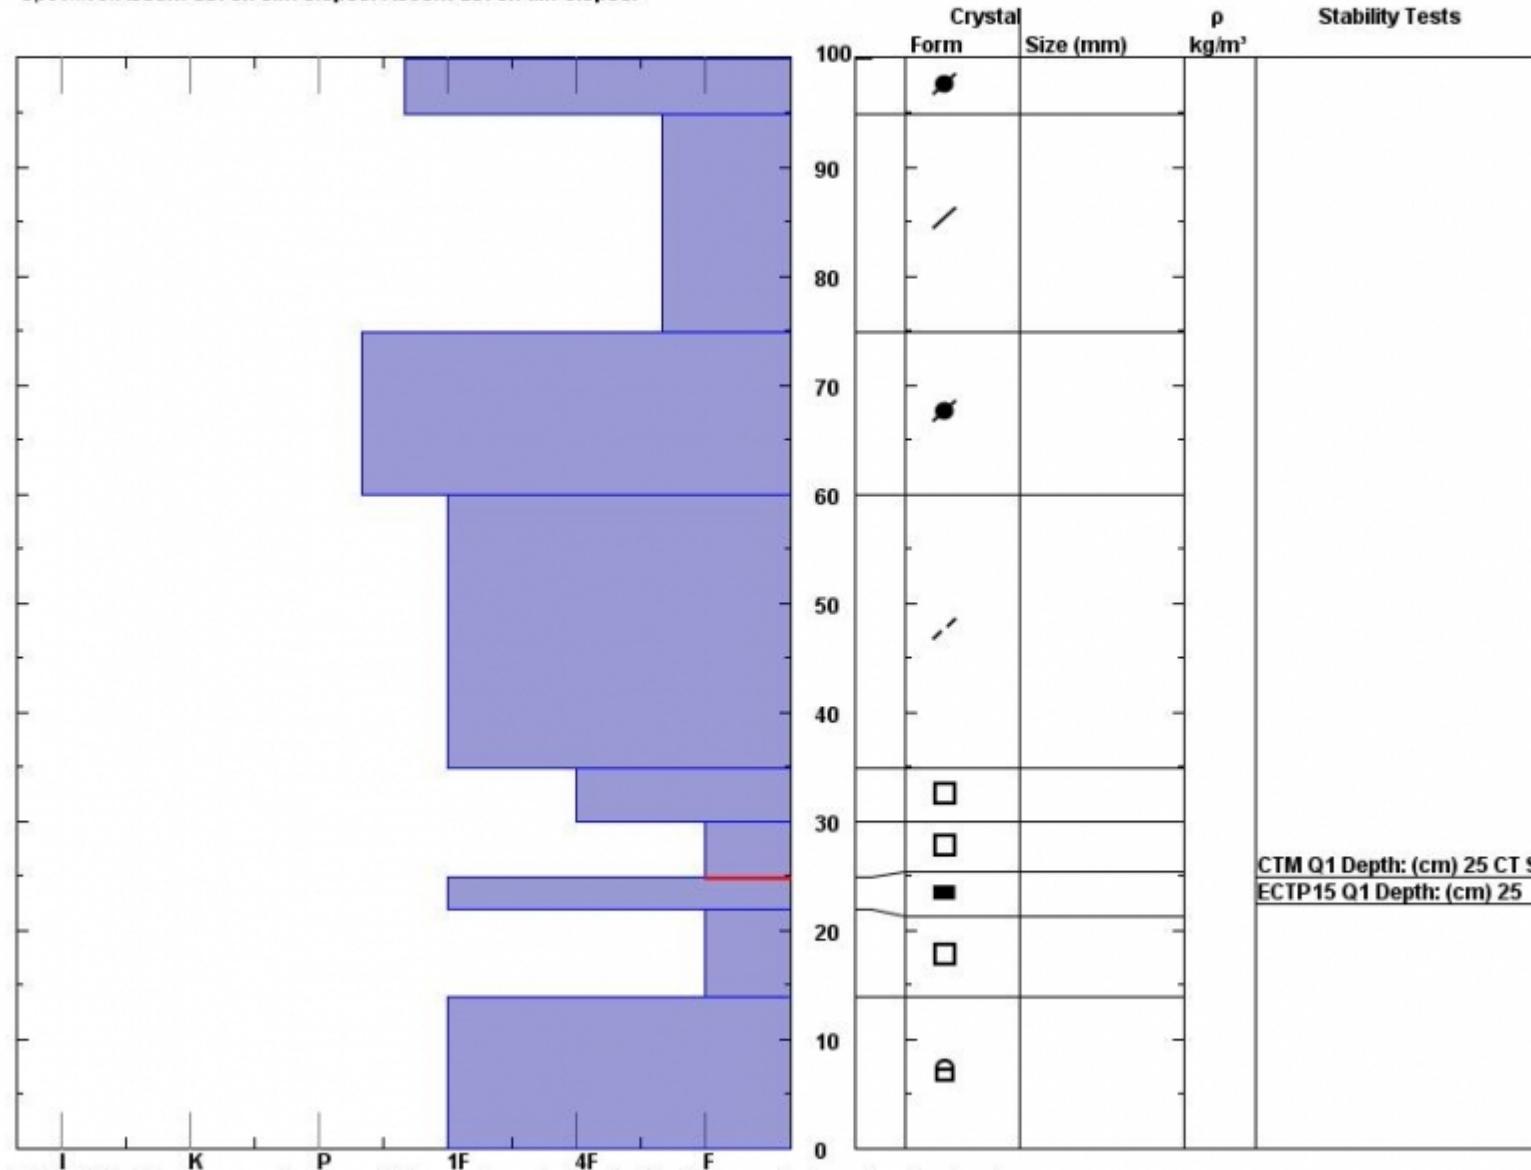
I K P IF 4F F U Notes: Weak facets near the ground stressed by a heavy wind load are producing natural avalnaches.

Natural avalanche activity was observed in the Mt blackmore area. A heavy wind load sitting over weak facets produced the slides.
