Advisory Region Northern Gallatin Northern Gallatin, 2012-01-03

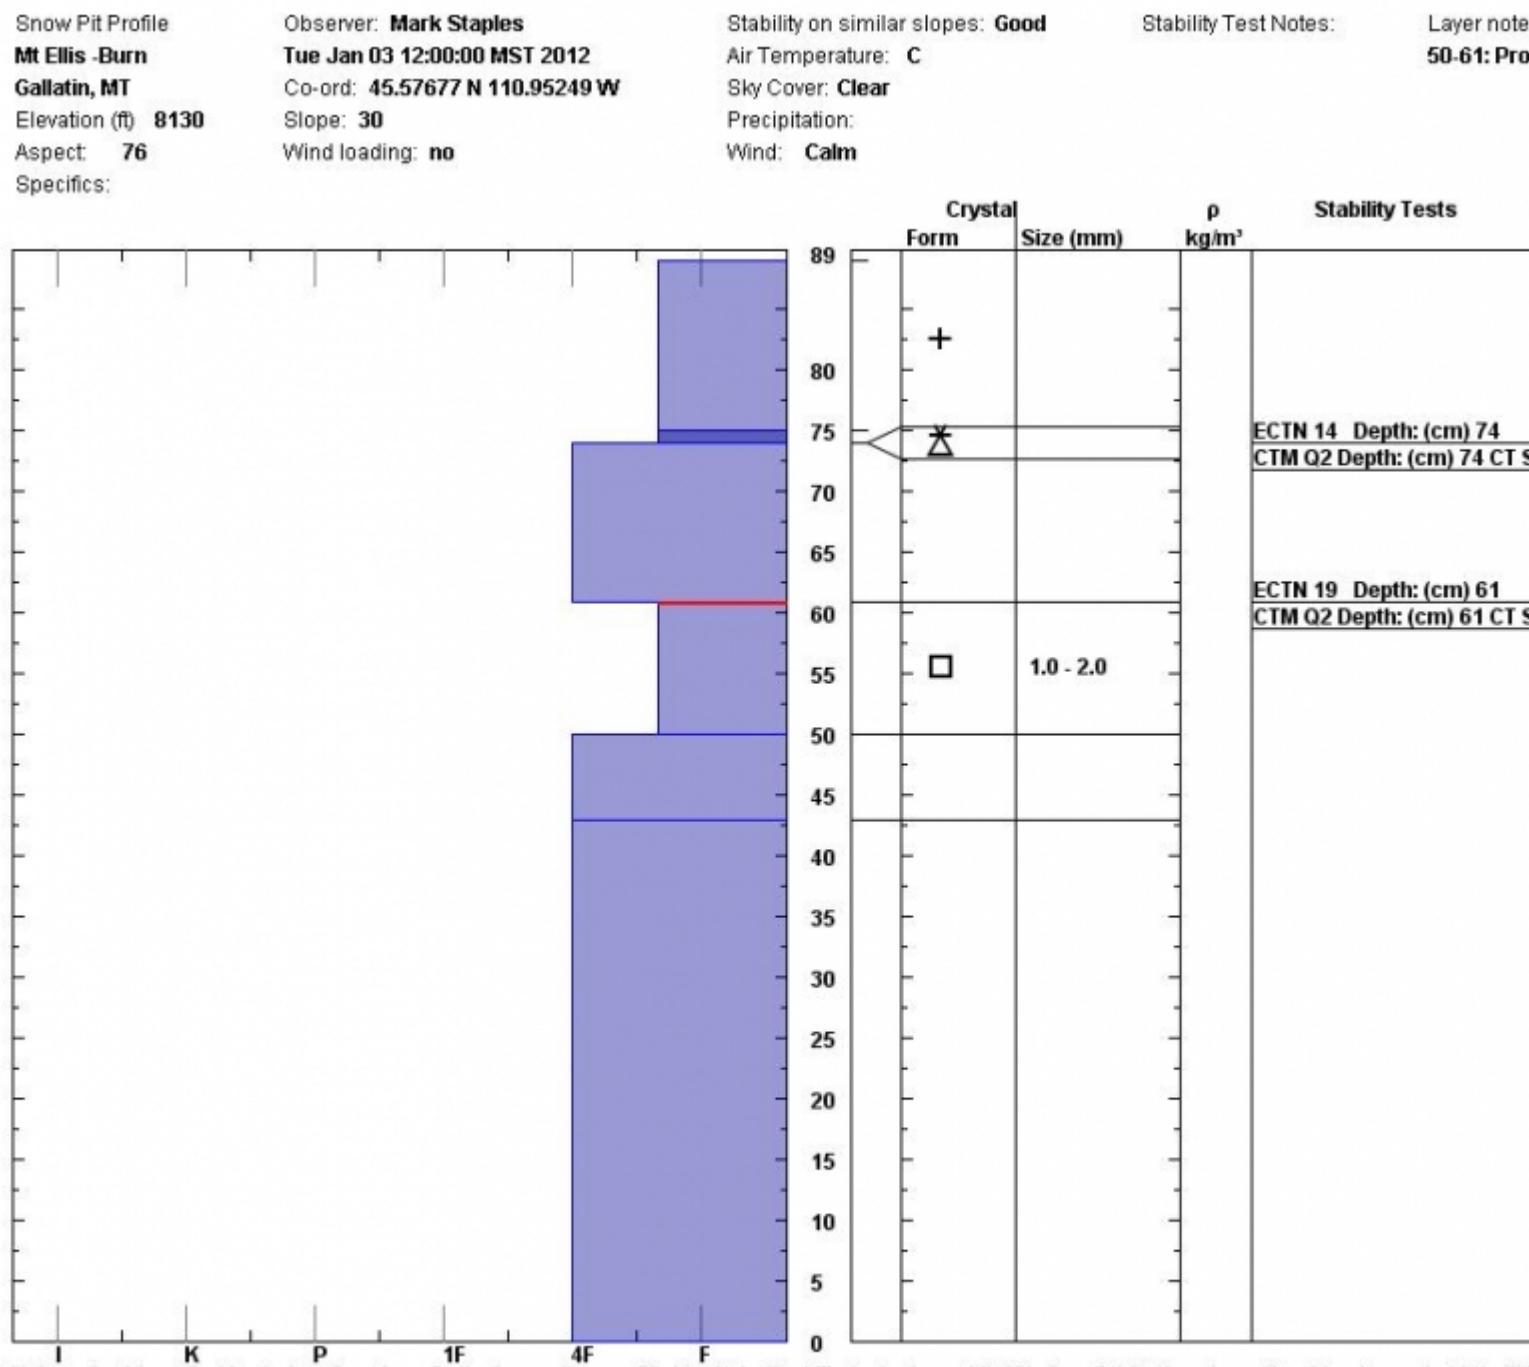
I K P 1F 4F F Notes: Could not find buried surface hoar in the burned area. Slight wind affect likely destroyed it. We found it further down the ridge towards Little Ell where it was very reactive (CT2 Q1). No collapsing or cracking. We found more surface hoar in a low angle meadow below the burn. Near the crystals were 2-4mm fx's and depth hoar and became just facets further up the snowpack.
