Advisory Region Lionhead Range Lionhead Range, 2012-01-26

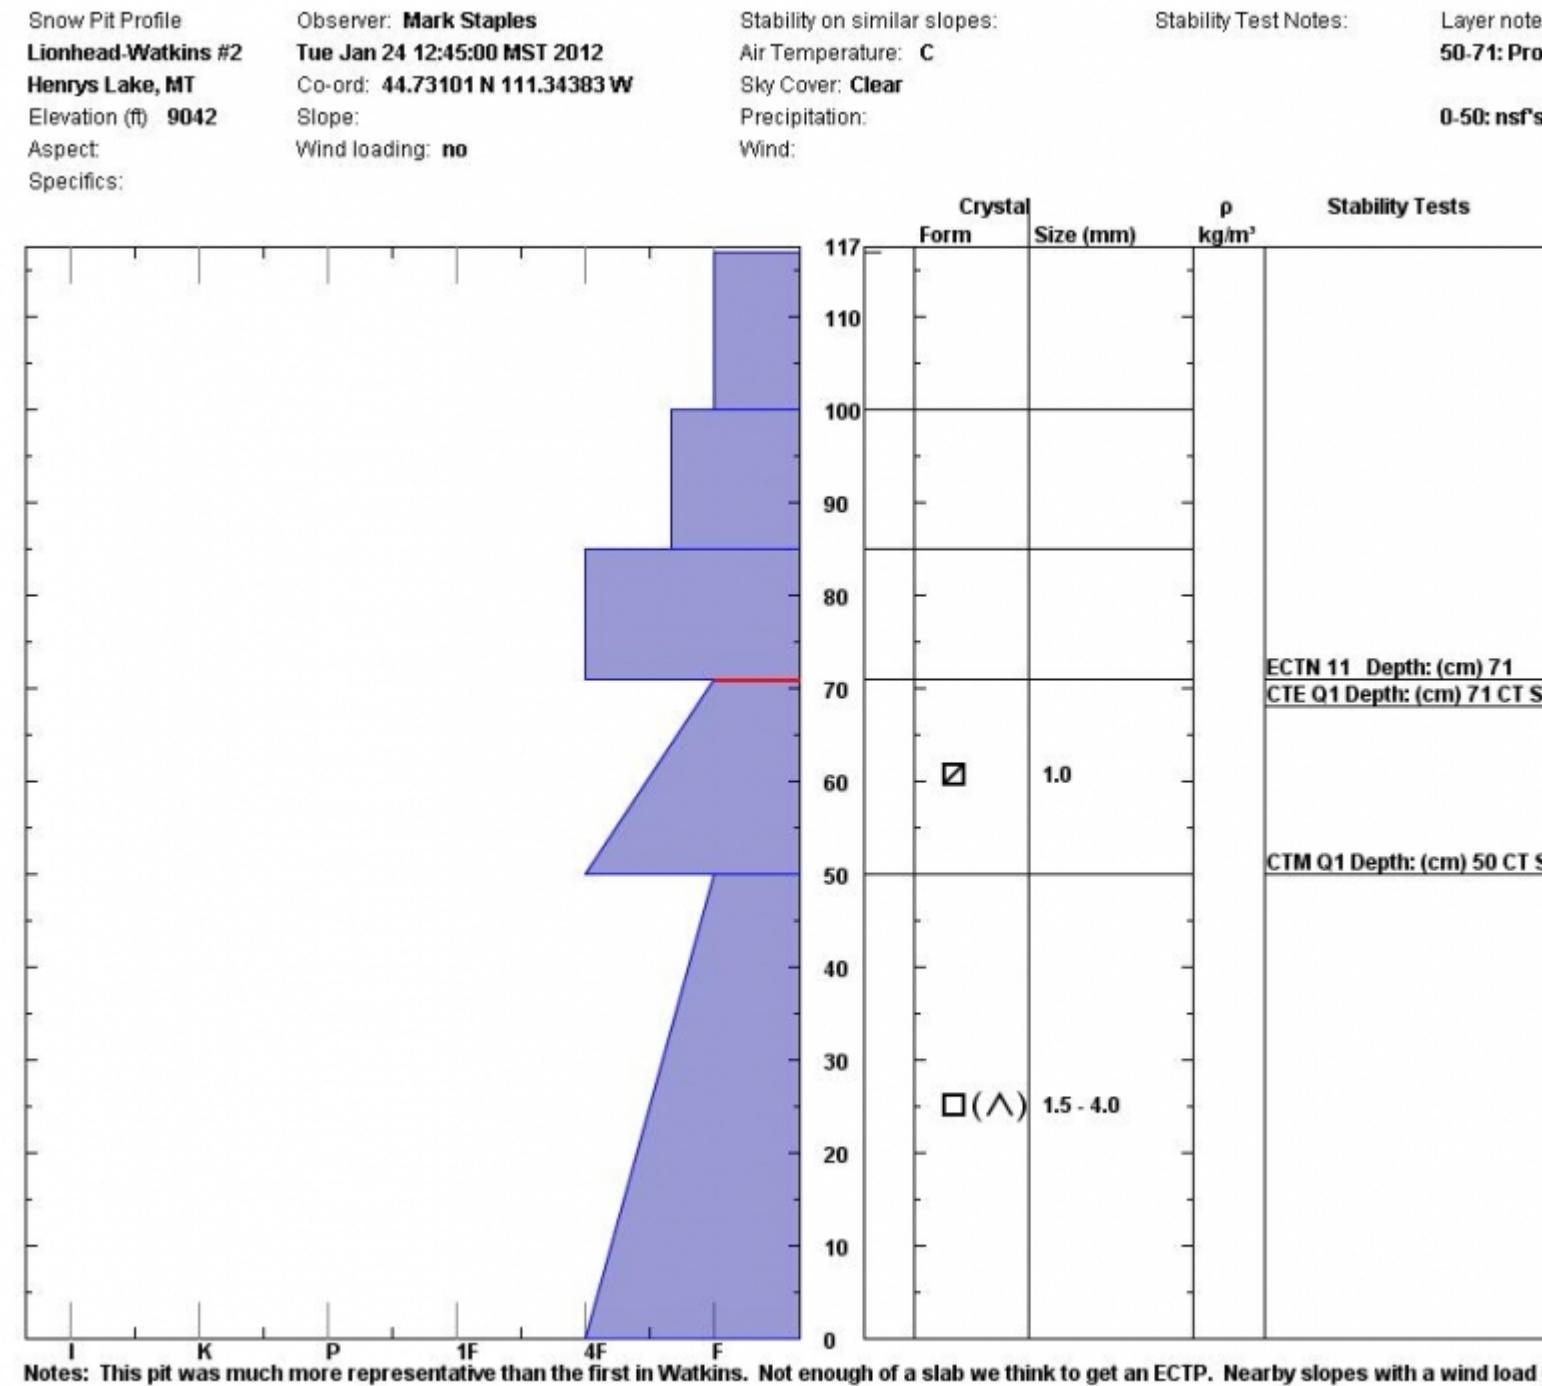
lotes: This pit was much more representative than the first in Watkins. Not enough of a slab we think to get an ECTP. Nearby slopes with a wind load avalanches and propagated for several 100 feet. A few small avalanches (less than 30ft wide) occurred on similar terrain with no wind load. S nearby avalanche: http://www.mtavalanche.com/images/12/natural-avalanche-lionhead
