Advisory Region Northern Madison Northern Madison, 2012-01-31

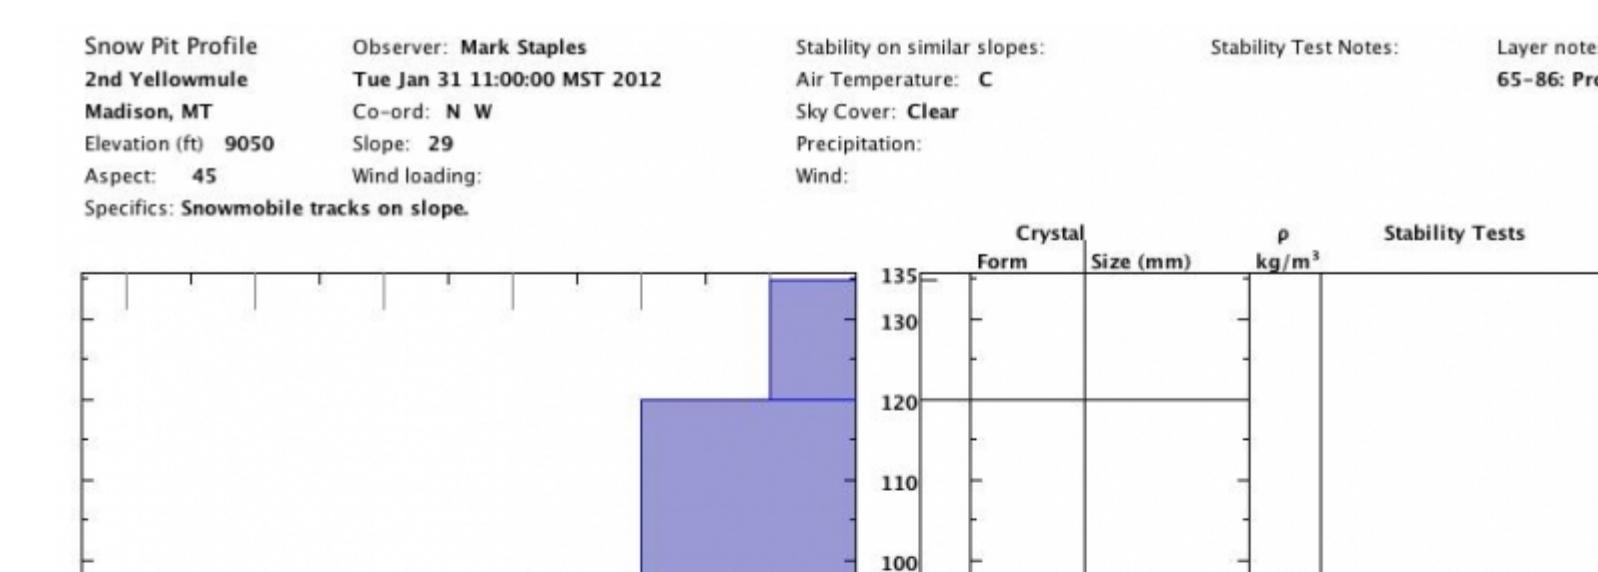
I K P 1F 4F F 0 Notes: This pit was dug under a natural avalanche that broke about 2000ft wide on a heavily wind loaded slope. This pit location had just the slighter

ECTP13 Q1 Depth: (cm) 86

ECTP27 Q1 Depth: (cm) 25
