Advisory Region Cooke City Cooke City, 2013-12-06

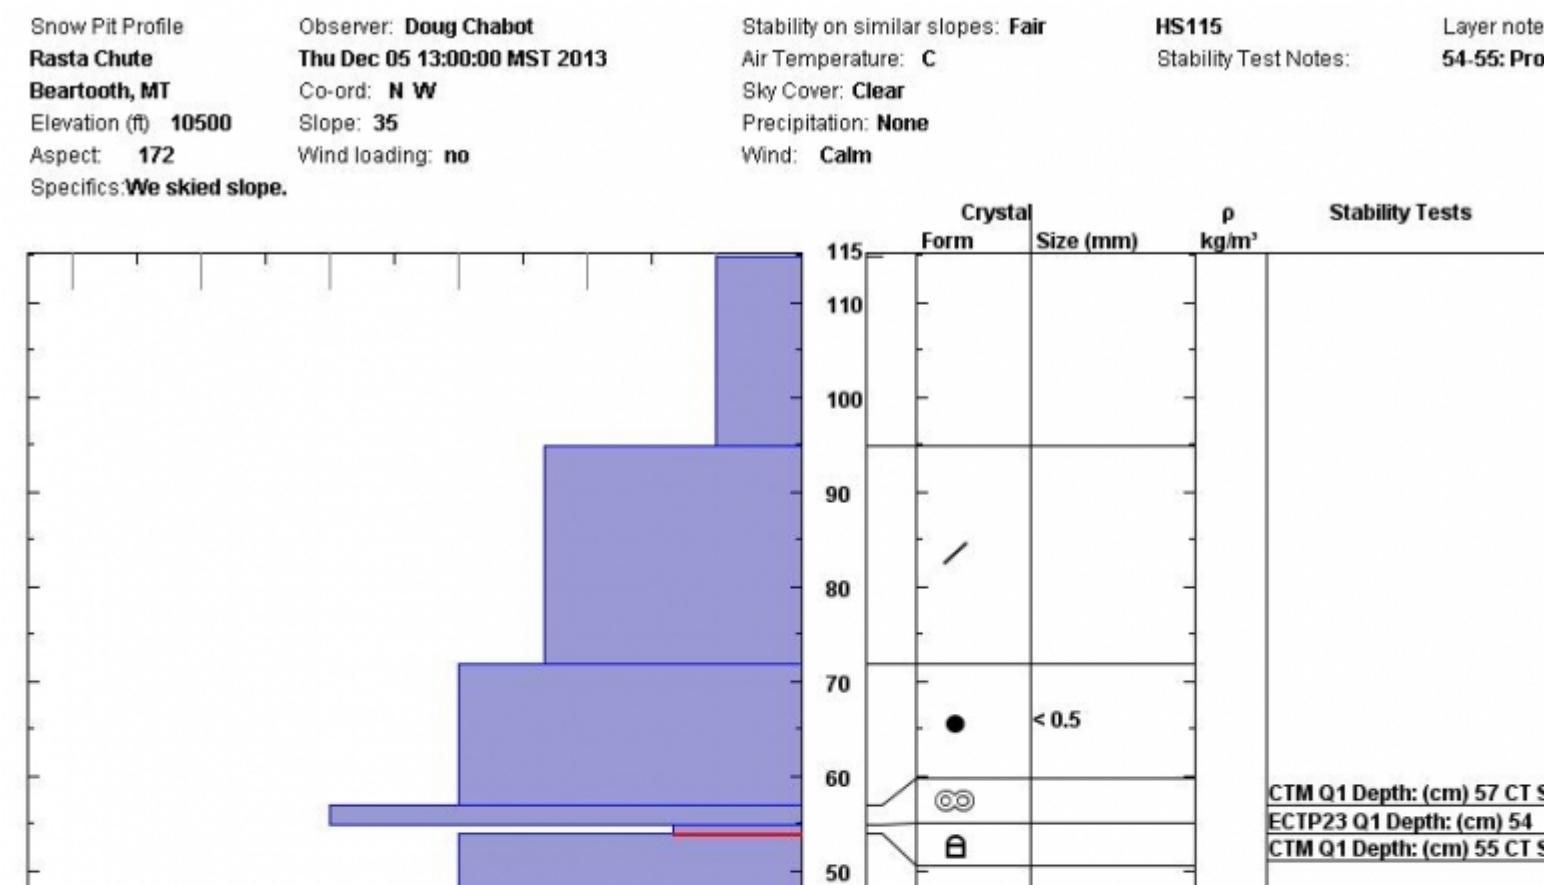
2x ECTN 17 Depth: (cm) 57

I K P 1F 4F F U Notes: This south facing slope was looking good. No lingering stability issues. We did not see any avalanches on this aspect either.
