Advisory Region Cooke City Cooke City, 2013-12-06

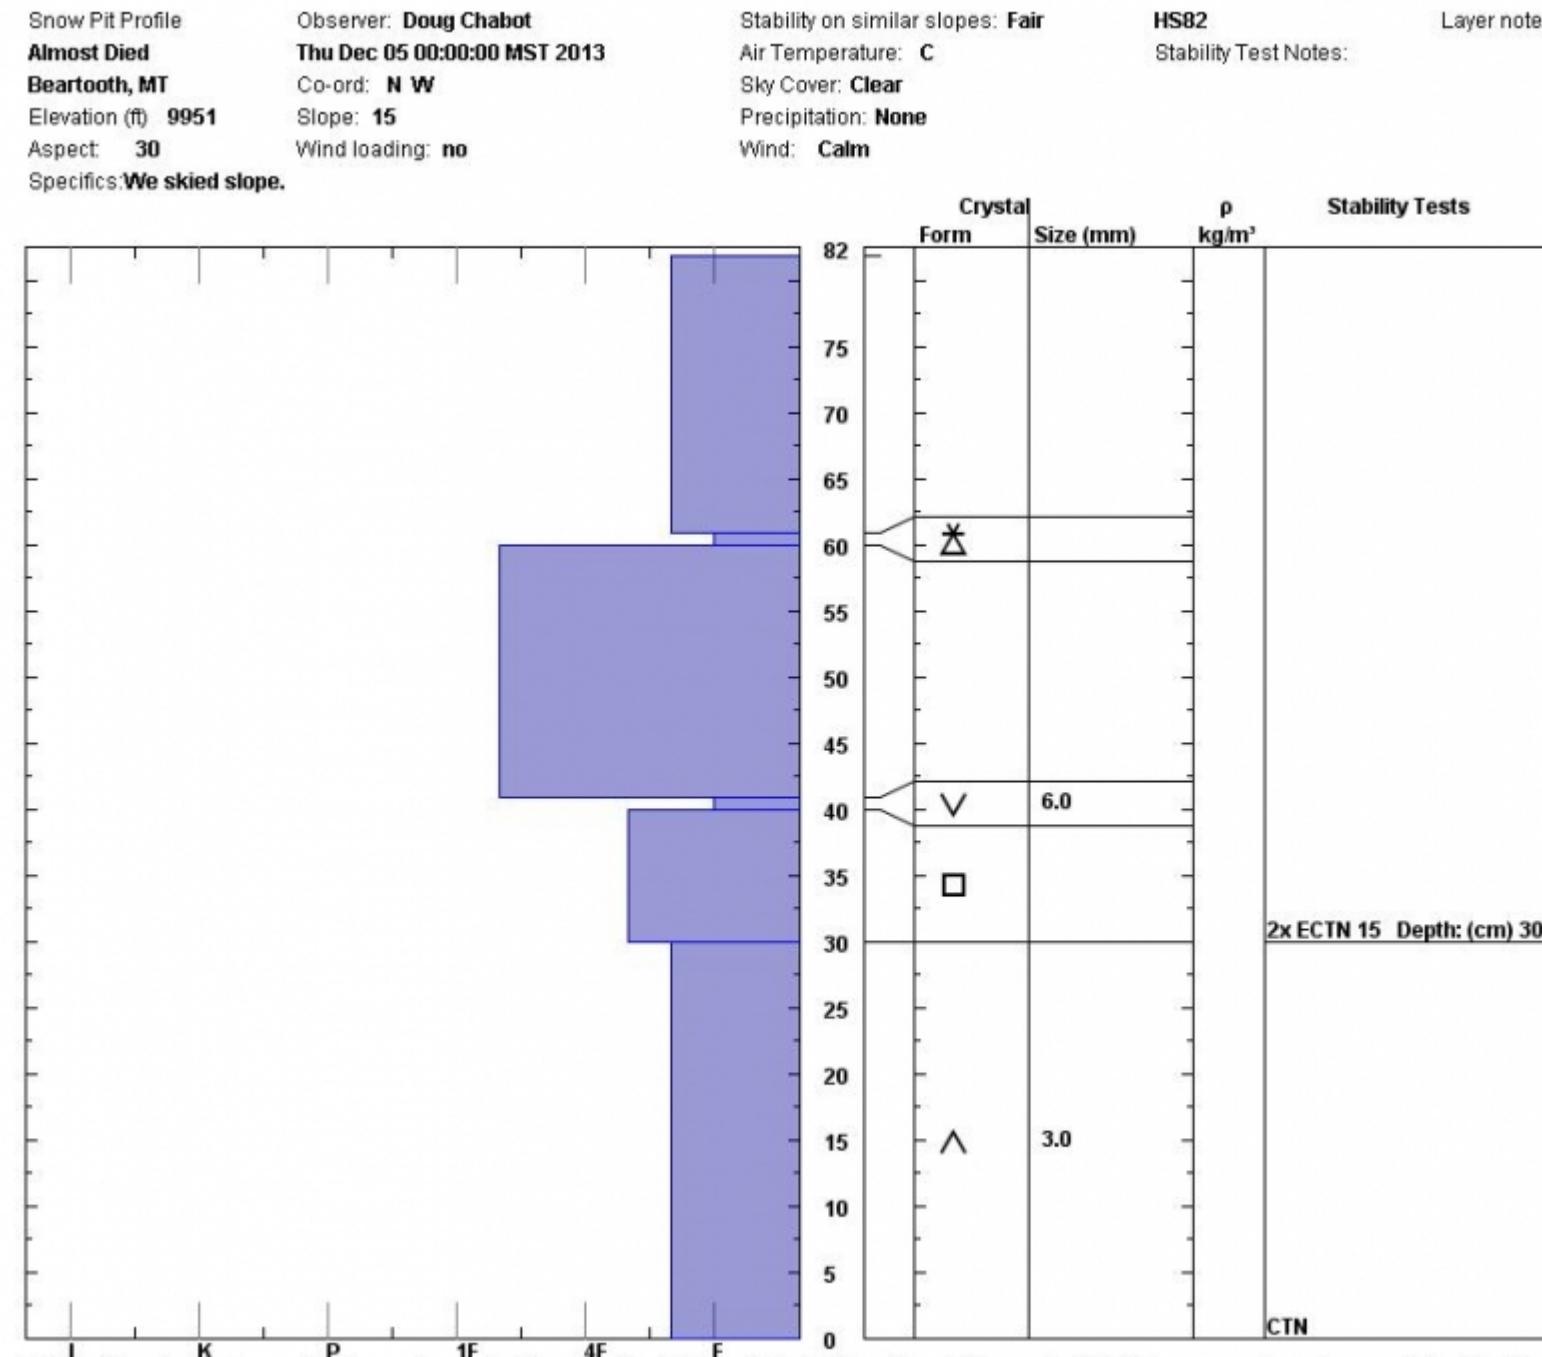
I K P 1F 4F F U Notes: This pit was dug on Henderson Bench to determine the stability of the Surface Hoar. It is very visible in the snowpack and seems to be standing does not fracture. I don't trust it.
